# **REPORT ON SITE SERVICES STUDY**

**TORONTO ZOO**

**PARADIGM ENGINEERING GROUP INC.  
Project No: 850**

September , 1999

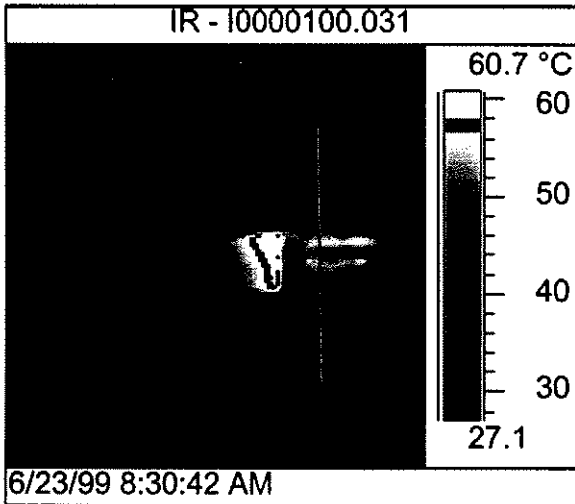
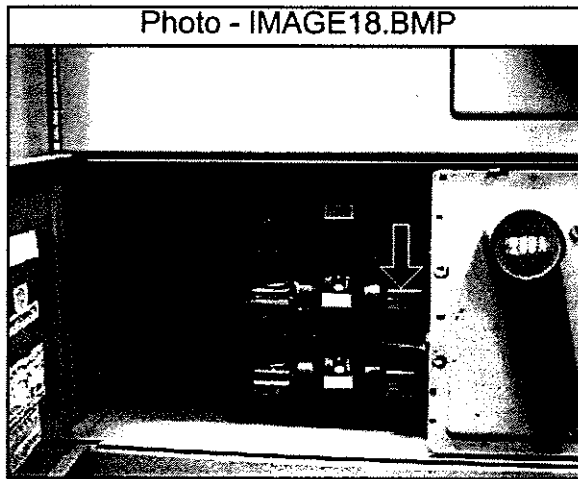
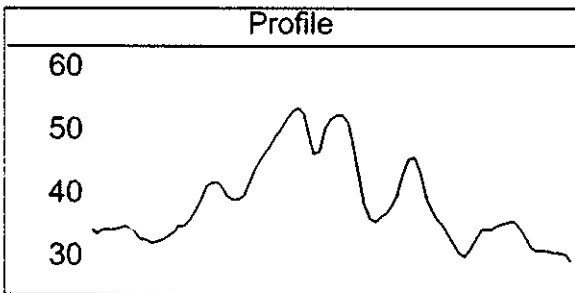
**Job No.:** 6621  
**Customer:** Metropolitan Toronto Zoo  
**Site Location:** Toronto, Ontario  
**Equipment I.D.:** F.P.E. 200A 120/208V Disconnect (Auto Transfer Sw.)  
**Equipment Location:** Indo Pavilion Main Electrical Room  
**Inspection Date:** 5/2/89 1:18:15 AM

Surface Profile Minimum Temperature:	29.7 °C
Isotherm Area Temperature:	58.0 °C
Surface Profile Maximum Temperature:	54.0 °C

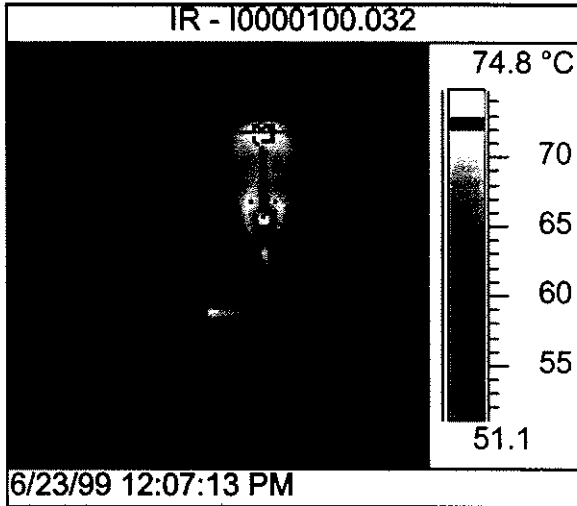
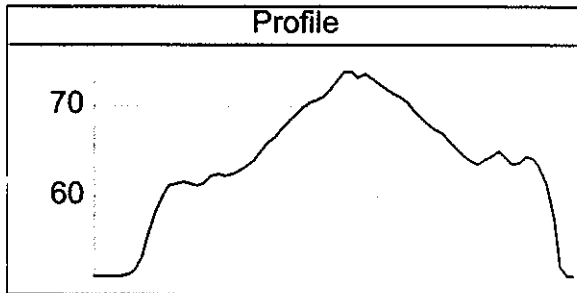
**Job No.:** 6621  
**Customer:** Metropolitan Toronto Zoo  
**Site Location:** Toronto, Ontario  
**Equipment I.D.:** Square 'D' 60A Starter Fan #5 General Supply-EU1001  
**Equipment Location:** Australasia Pavilion  
**Inspection Date:** 5/2/89 5:37:40 AM

Surface Profile Minimum Temperature:	<51.1 °C
Isotherm Area Temperature:	72.9 °C
Surface Profile Maximum Temperature:	73.9 °C
