**REQUEST FOR PROPOSAL  
SITE SERVICES STUDY  
RFP # 12 (2018-03)**

# **REPORT ON SITE SERVICES STUDY**

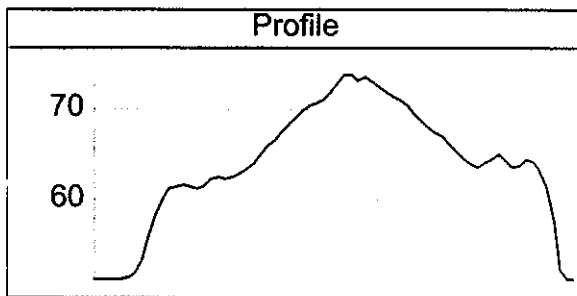
Surface Profile Minimum Temperature:	<51.1 °C
Isotherm Area Temperature:	72.9 °C
Surface Profile Maximum Temperature:	73.9 °C
