# **REPORT ON SITE SERVICES STUDY**

**TORONTO ZOO**

**PARADIGM ENGINEERING GROUP INC.  
Project No: 850**

September , 1999

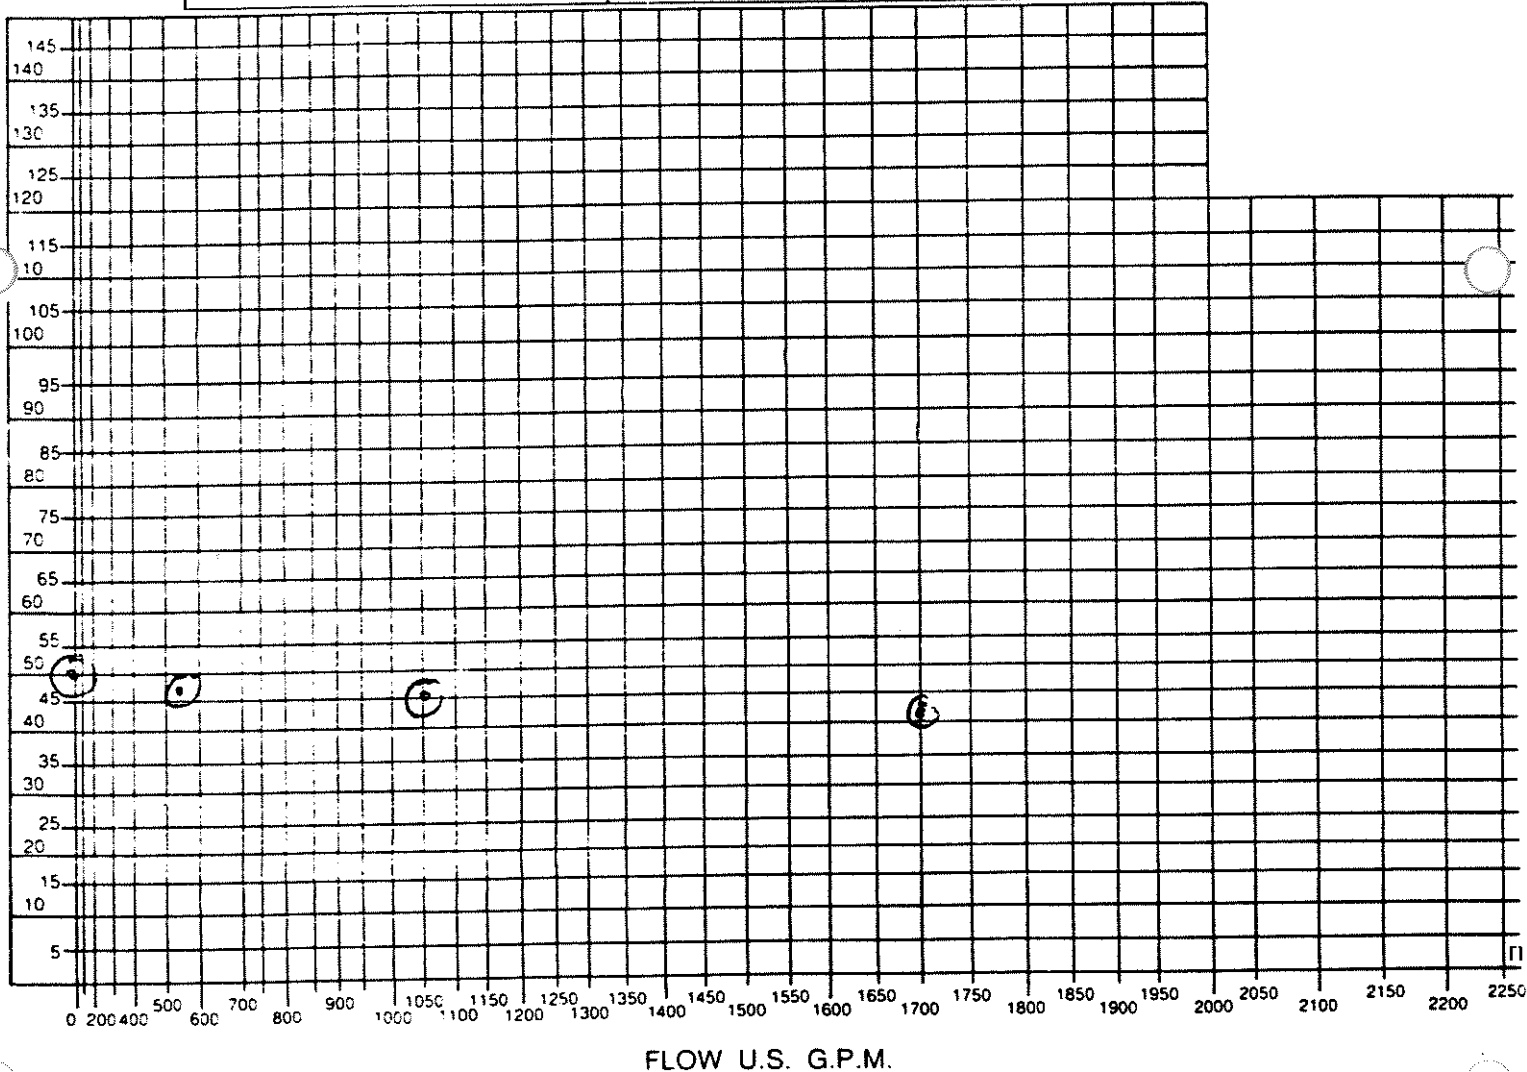
TIME OF TEST 11:00am  
LOCATION OF TEST (FLOW) Hydrant (N/E of Special Events Tent) #12  
(RESIDUAL) 3/4 hose bib (Siberian Tiger building) ♀  
MAIN SIZE 4" inch  
STATIC PRESSURE 50 psi

NUMBER OF OUTLETS & ORIFICE SIZE	PITOT PRESSURE	FLOW (U.S G P M)	RESIDUAL PRESSURE
#1	1 X 1 3/4"	44	544	47
#2	1 X 2 1/2"	40	1056	45
#3	2 X 2 1/2"	26	1703	42
#4

COMMENTS FLOW TEST - BLUE

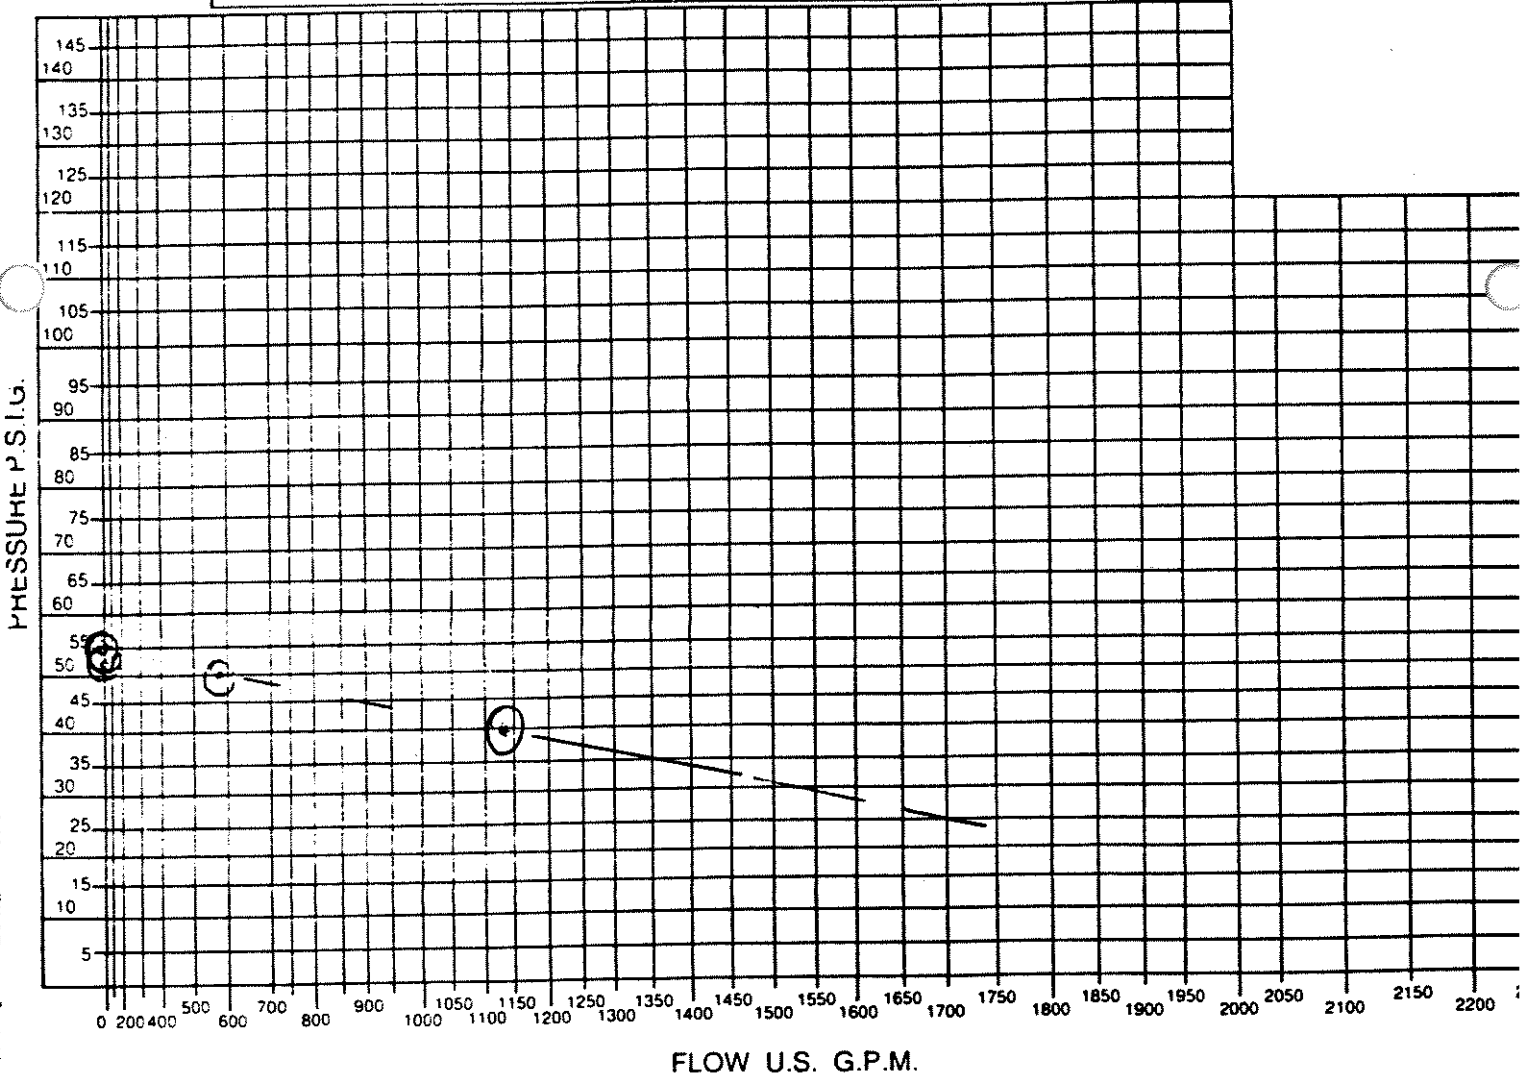
NUMBER OF OUTLETS & ORIFICE SIZE	PITOT PRESSURE	FLOW (U.S.G.P.M.)	RESIDUAL PRESSURE
#1 1 X 1 3/4"	52	591	50
#2 1 X 2 1/2"	46	1133	40
#3			
#4

COMMENTS: Unable to flow 2 X 2 1/2" inch due to surroundings. - FLOW TEST - [Signature]

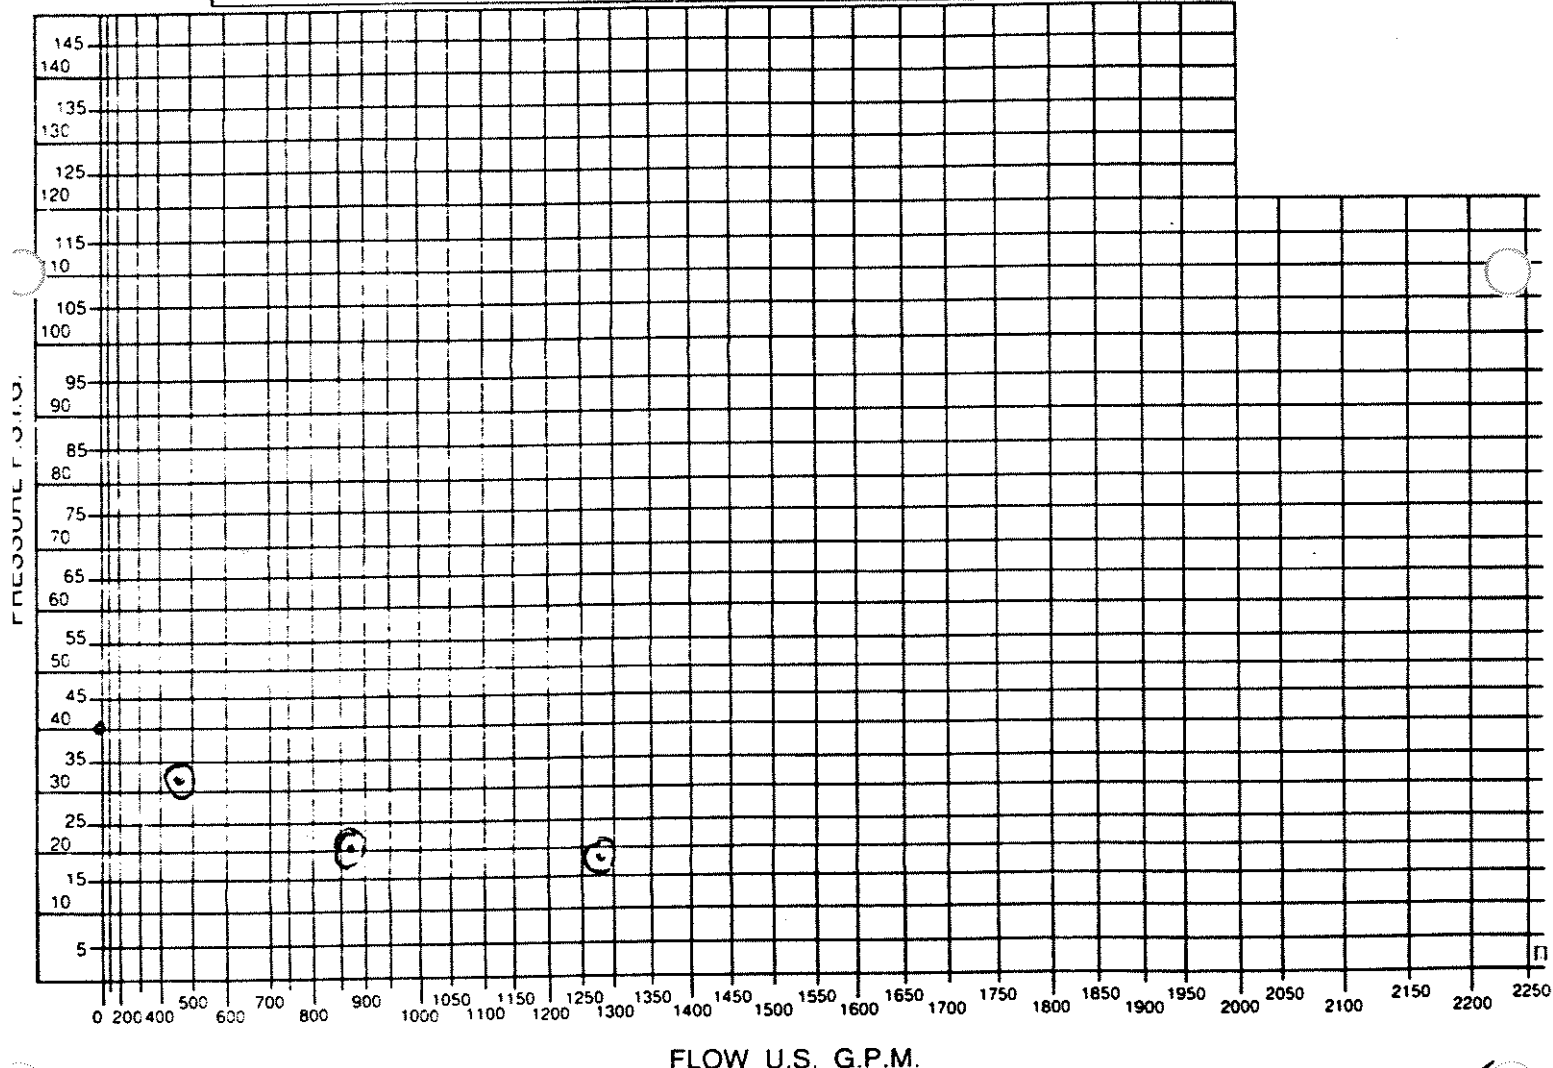
TIME OF TEST: 1:45 pm  
LOCATION OF TEST: (FLOW) Hydrant (Outside gorilla door) #4  
(RESIDUAL) Hydrant (West side of African Pavilion) #5  
MAIN SIZE 10" inch  
STATIC PRESSURE: 40

NUMBER OF OUTLETS & ORIFICE SIZE	PITOT PRESSURE	FLOW (U.S.G.P.M.)	RESIDUAL PRESSURE
#1	1 X 1 3/4"	32	46.3	32
#2	1 X 2 1/2"	27	86.8	20
#3	2 X 2 1/2"	15	129.4	28
#4

COMMENTS FLOW TEST - CR. 106 / CRP. 10
