**REQUEST FOR PROPOSAL  
SITE SERVICES STUDY  
RFP # 12 (2018-03)**

# **REPORT ON SITE SERVICES STUDY**

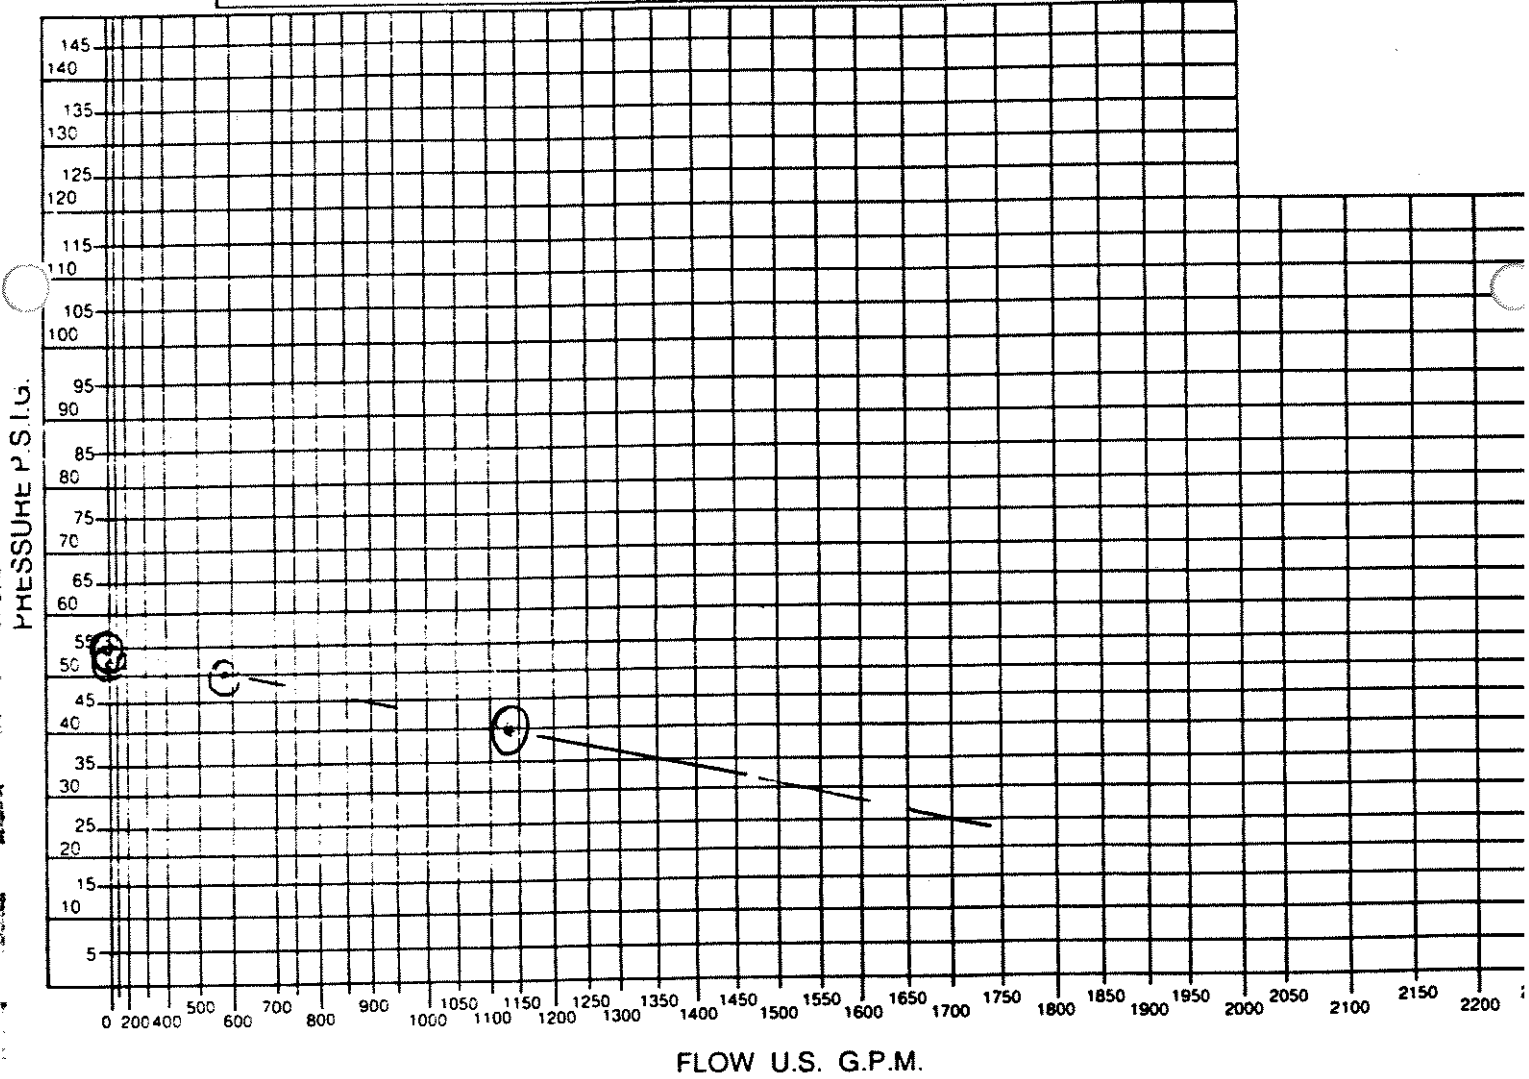
COMMENTS: Unable to flow 2 x 2 1/2" inch due to surroundings. - FLOW TEST - [Signature]

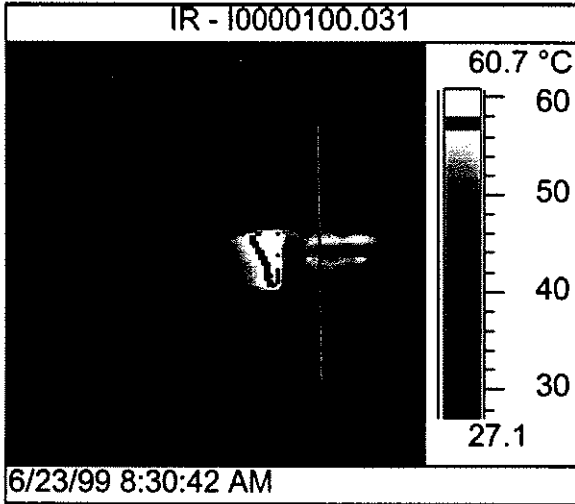
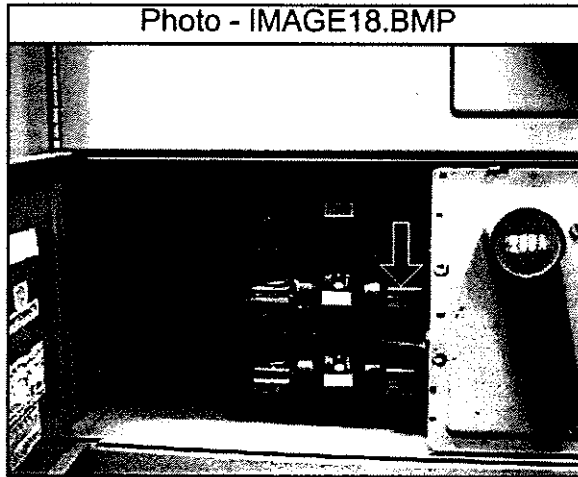
**Job No.:** 6621  
**Customer:** Metropolitan Toronto Zoo  
**Site Location:** Toronto, Ontario  
**Equipment I.D.:** F.P.E. 200A 120/208V Disconnect (Auto Transfer Sw.)  
**Equipment Location:** Indo Pavilion Main Electrical Room  
**Inspection Date:** 5/2/89 1:18:15 AM

Surface Profile Minimum Temperature:	29.7 °C
Isotherm Area Temperature:	58.0 °C
Surface Profile Maximum Temperature:	54.0 °C

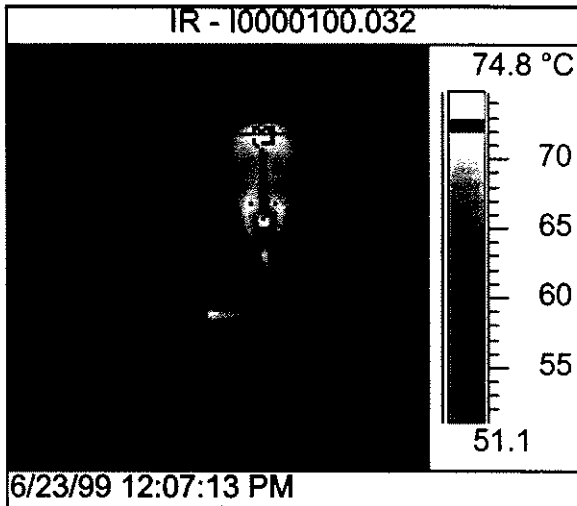
**Job No.:** 6621  
**Customer:** Metropolitan Toronto Zoo  
**Site Location:** Toronto, Ontario  
**Equipment I.D.:** Square 'D' 60A Starter Fan #5 General Supply-EU1001  
**Equipment Location:** Australasia Pavilion  
**Inspection Date:** 5/2/89 5:37:40 AM

Surface Profile Minimum Temperature:	<51.1 °C
Isotherm Area Temperature:	72.9 °C
Surface Profile Maximum Temperature:	73.9 °C
